Visual Property Inspection

237A Leslie St
Toronto, ON M4M 3C8

Report Commentary

Date: 29-Apr-2016

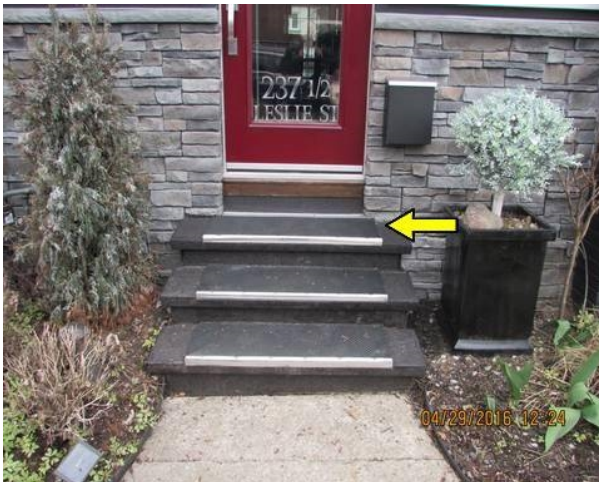
Front Porch Rail

Missing handrail

Install handrail to promote safety.

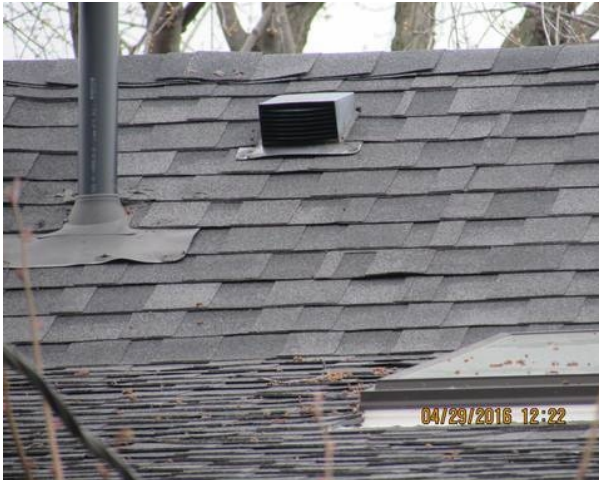
Main Roof

Architectural shingles are in good condition. Typical life expectancy of this type of shingle is 25 to 30 years.

Roof covering

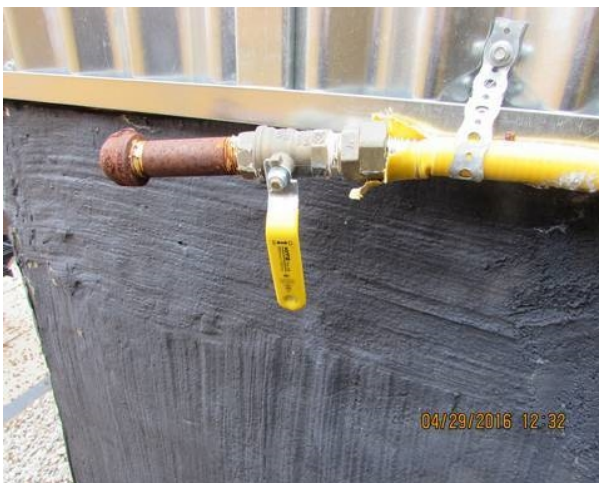
Pipes/Ducts

External Gas shut off

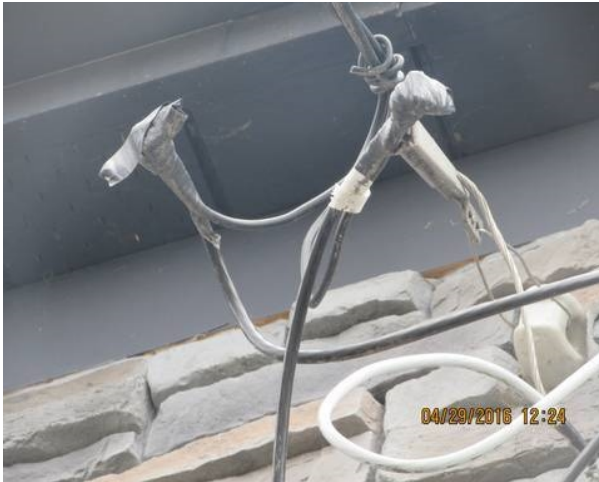
Entrance Cable

No drip loop

Consult utility to correct drip loop to control water run off

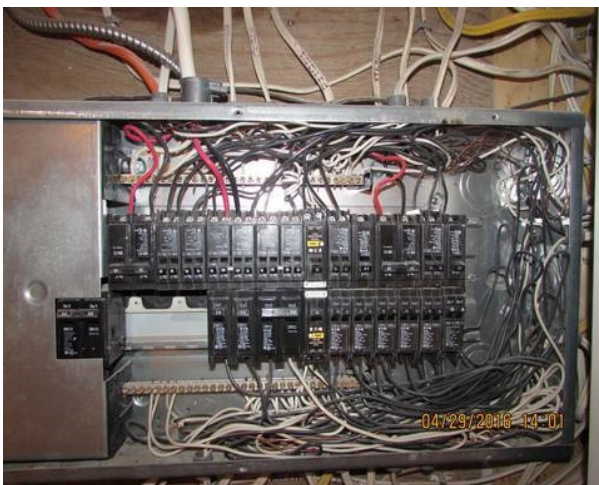
Distribution Panel

Electrical panel

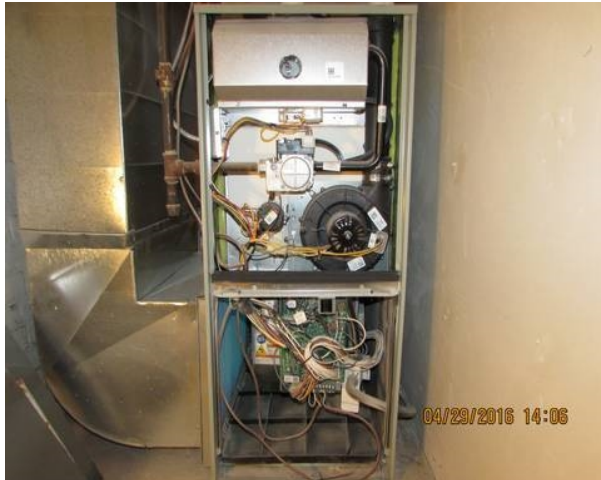
Heating System Advise Service/Repair Contract Verify Service Hist w/Selle*High efficiency furnace is 2 years old and functioning as intended. Typical life expectancy is 20 years.***Operational**

High efficiency furnace

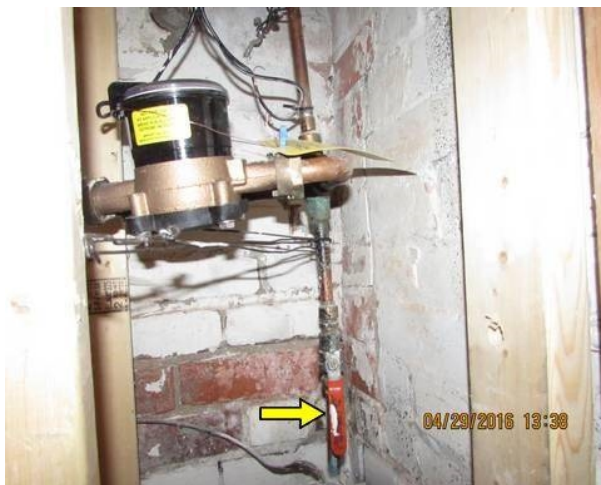
Public Supply

Water meter and main shut off

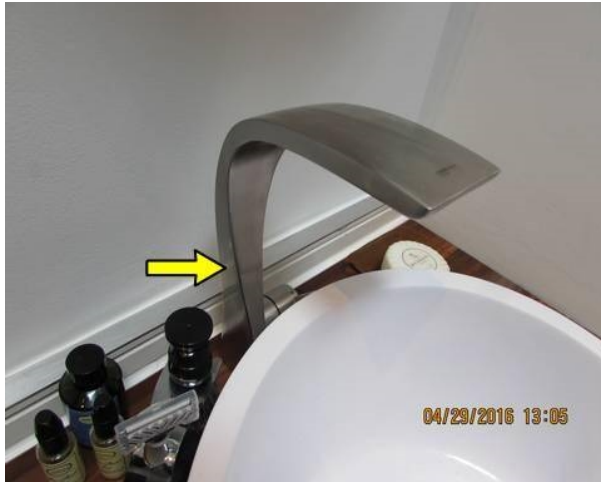
Faucet not secure
